ARINC Research Publication 2315-11-1-2635

**FINAL ENGINEERING REPORT
IMPROVEMENT PROGRAM FOR THE
C-141 NAVIGATION SELECTOR PANEL**

January 1982

**Prepared for
RELIABILITY ENGINEERING BRANCH
ITEM MANAGEMENT DIVISION
MMIRCA-4
ROBINS AIR FORCE BASE, GEORGIA 31098
under Contract F09603-80-G-3338-0012**

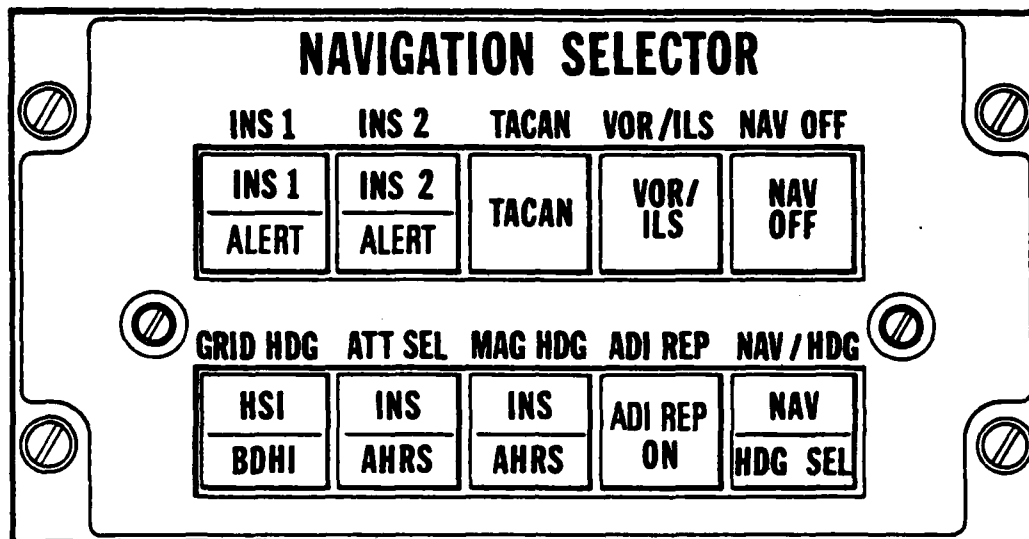
Figure 1-1. NAVIGATION SELECTOR PANEL (FRONT VIEW)

The Navigation Selector Panel (NSP) for the C-141 aircraft has experienced chronic switch-assembly failures that have had an adverse effect on the availability of navigation systems. The failures are primarily of the lighted push-button switches and, to a lesser degree, the printed circuit board. Problems include sticking push buttons, shorting of internal switch contacts, and failure of the push-button retainer mechanism, which allows the push buttons to fall out of the switch housings. Printed circuit board failures include burned tracks and components.

The NSP (see Figure 1-1) consists of nine lighted push-button switches and one indicator mounted in two rows. Two NSPs are used on each C-141 aircraft to provide the pilot and copilot a means of switching navigation signals on their respective flight instruments. The NSP controls a bank of remotely located relays that perform the system switching. In addition, the unit contains relays for lamp testing and dimming, which are driven by lamp testing and dimming signals from the aircraft's electrical system. The NSP also contains a circuit board with diodes and resistors that control the electrical current to the lamps. A more complete description of the system can be found in the Technical Manual, Intermediate Maintenance Instructions with Illustrated Parts Breakdown, T.O. 5N6-9-9-2, dated 1 December 1979.
